# Built Like Bridges

## Iron, Steel, and Rivets in the Nineteenth-century Skyscraper

THOMAS LESLIE  
Iowa State University

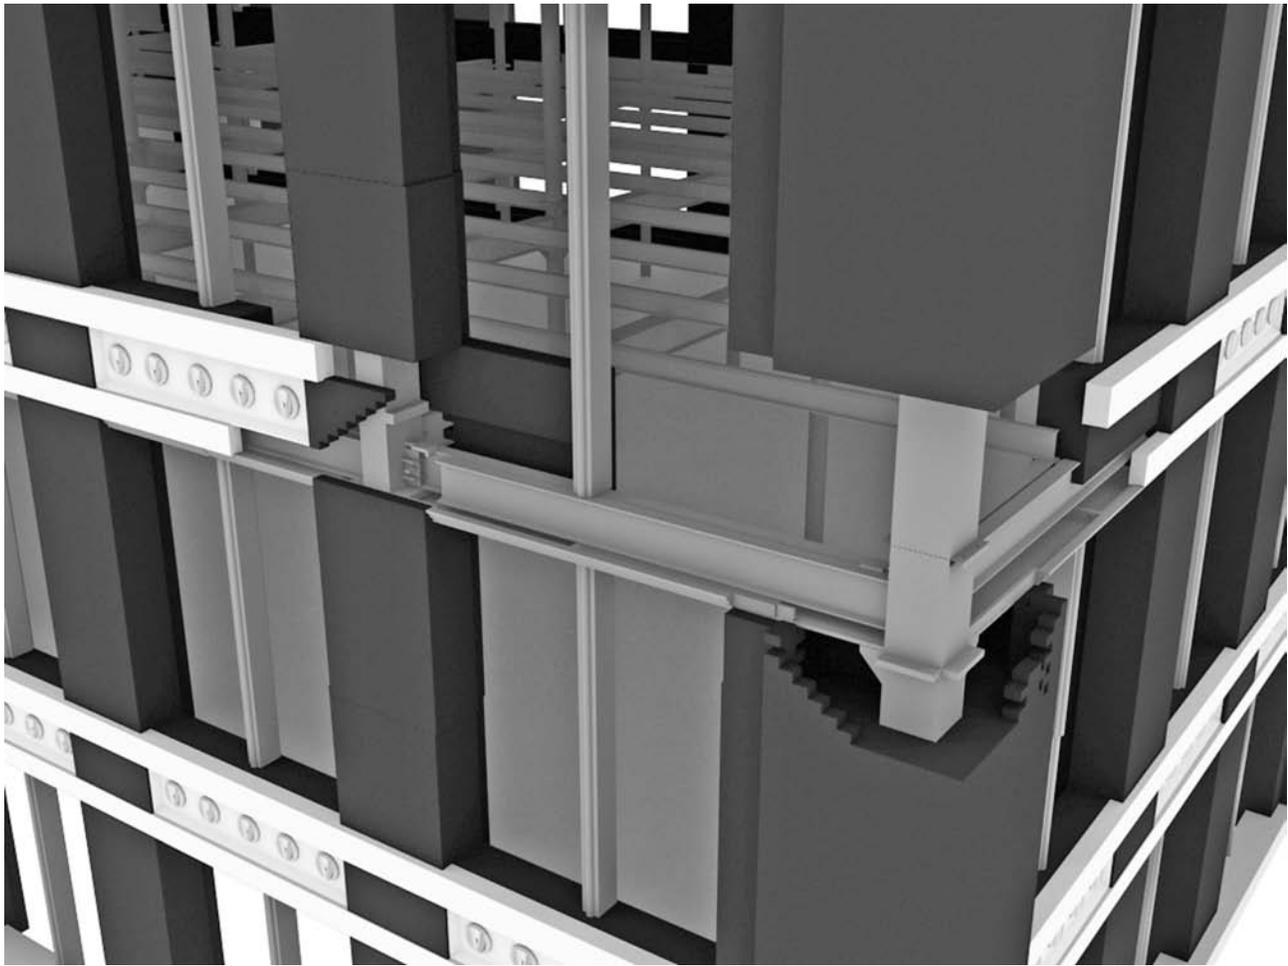
**Figure 1** William LeBaron Jenney, Home Insurance Building, Chicago, 1885 (demolished 1931). View of digital reconstruction showing reinforced masonry walls (model and view by Ryan Risse). See *JSAH* online for zoomable model

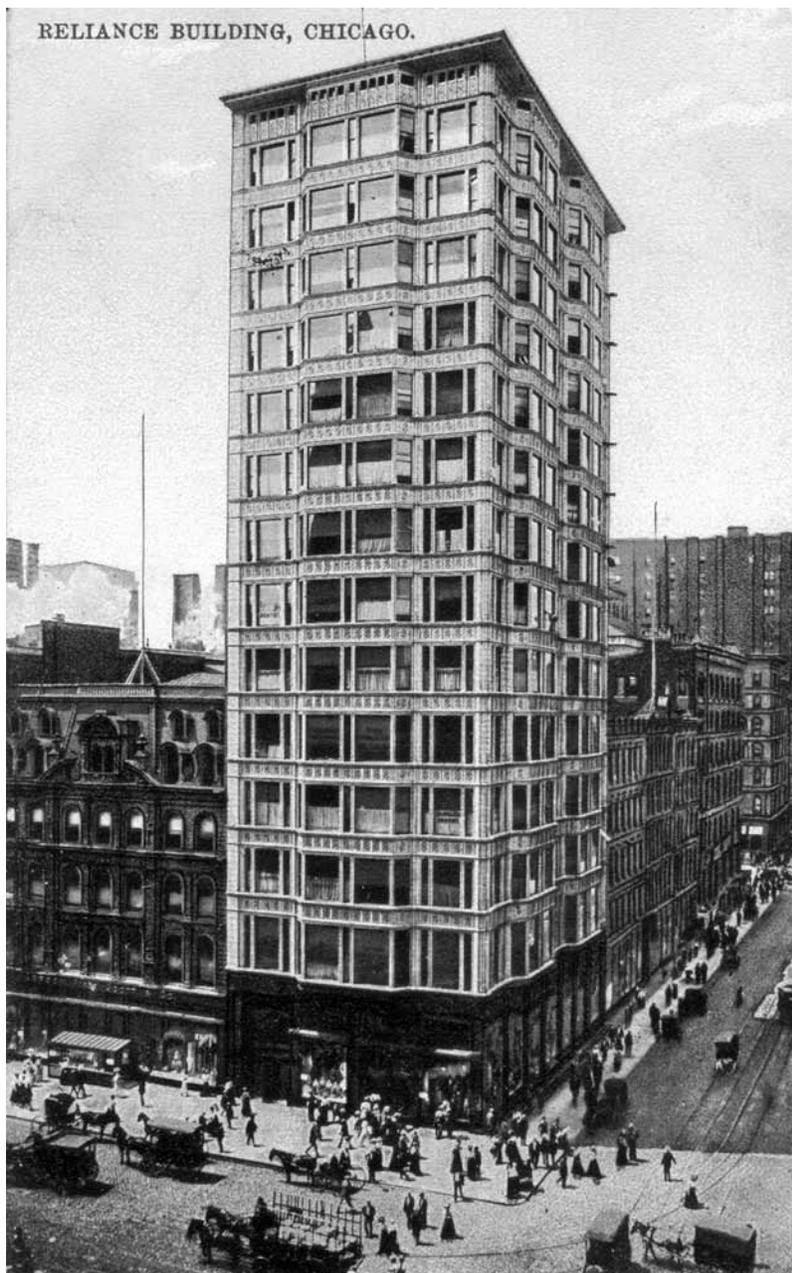
**Figure 18** Reliance Building, digital reconstruction showing relationship between self-braced steel structure and skin. See *JSAH* online for interactive model (model and view by Ryan Risse)
